Investigation Report into Flooding- Storm Callum 12th - 14th October 2018

Title of document Storm Callum S19 Flood Investigation Report

Document date March 2019

Authors Carmarthenshire County Council

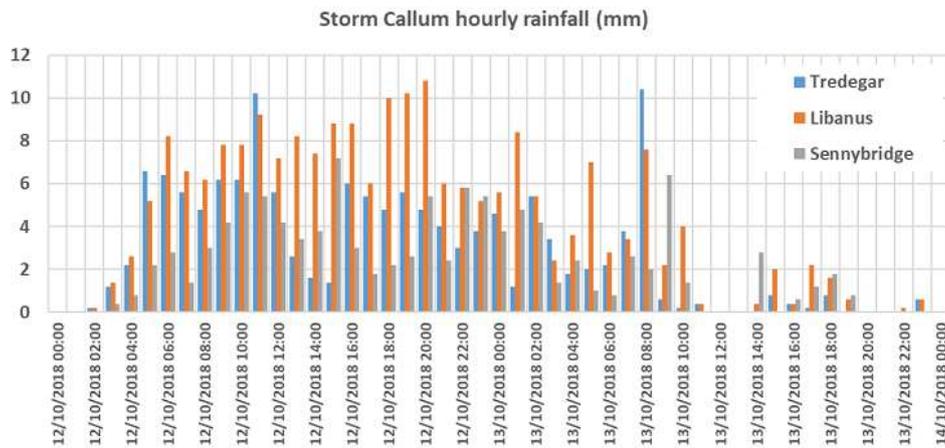
Figure 2 – Storm Callum Hourly Rainfall at Tredagar, Libanus and Sennybridge.

Figure 2 below highlights hourly rainfall in the Beacon Beacons. The Met Office has concluded that the extreme nature of the event was due to the duration of the event rather than the intensity.

The Met Office has concluded that, in terms of historical context, the 11th-12th October 2018 was one of the most notable and extreme rainfall / flood events across south Wales in the last 50 years.

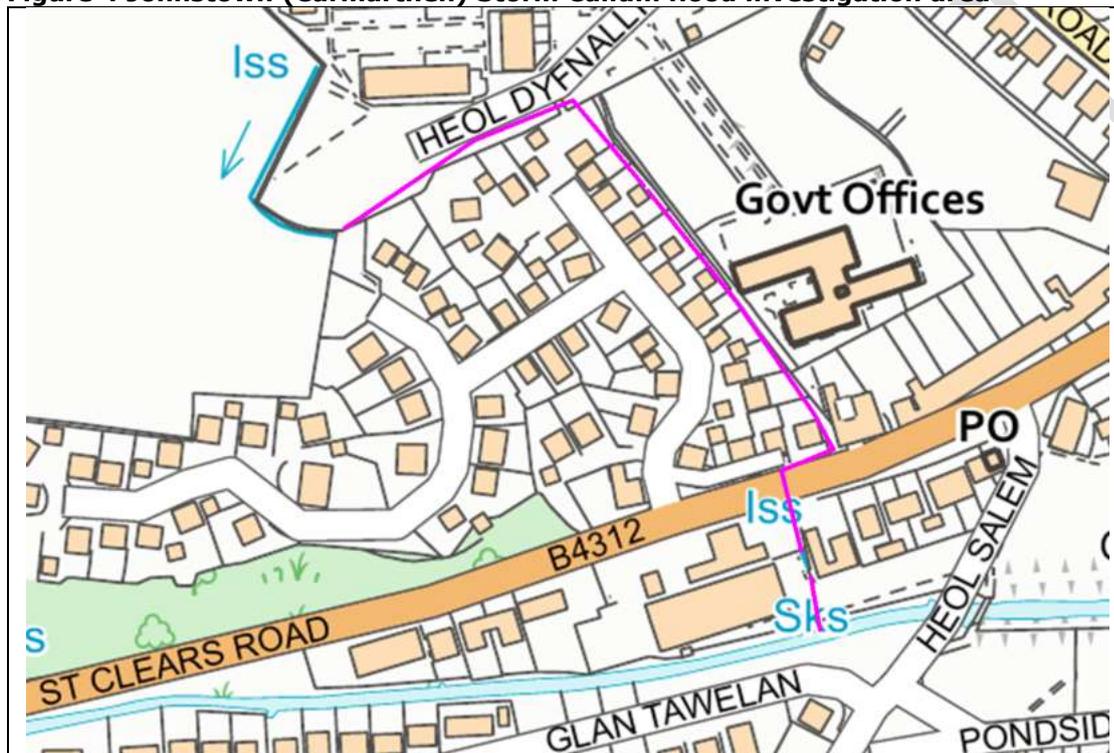
Figure 4 Johnstown (Carmarthen) Storm Callum flood investigation area

This investigation will focus specifically and predominantly on the residential area to the north of the A40 and the flooding that occurred as a result of Storm Callum. Map 1 below highlights the investigation area.

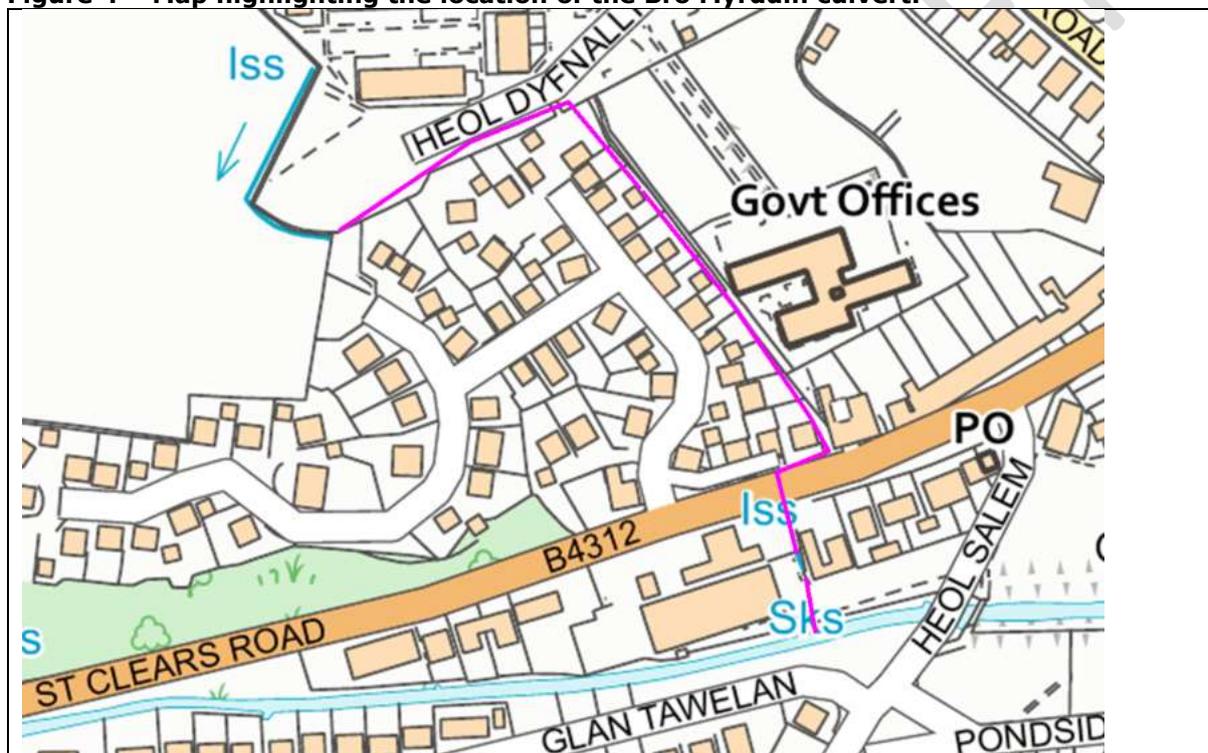
Figure 4 – Map highlighting the location of the Bro Myrddin culvert.

An evaluation of the drainage infrastructure, utilising a 2018 CCTV survey, has concluded that the system is of sufficient size to convey the above storm events.

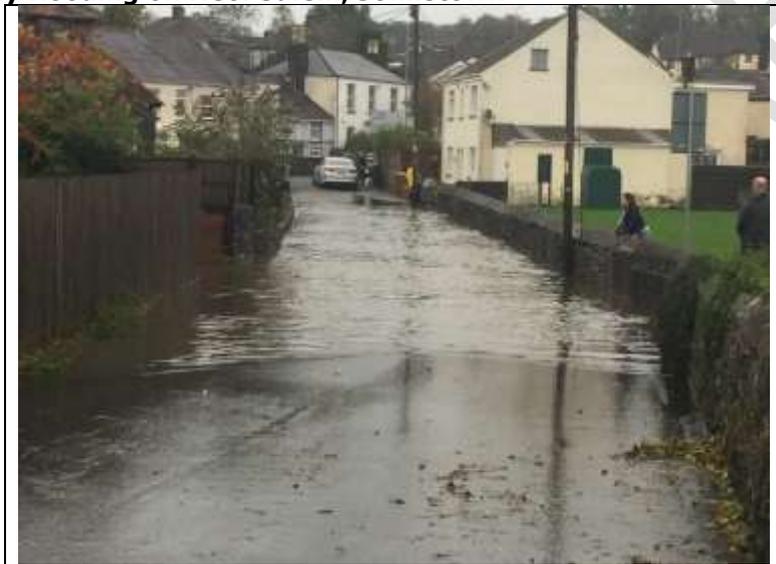
The highway network is drained via highway gullies. The Highway Authority have the gullies mapped on their asset management system WDM; these are cleaned annually. There is no information available on where the gullies drain to or the standards and conditions of these carrier drains. It is assumed that this discharges into the DCWW surface water system.

Plate 1: Highway flooding on Heol Salem, Johnstown

Action 2: CCC Highways Authority to work with DCWW to evaluate the standard of service and the condition of the highway drainage in Johnstown.

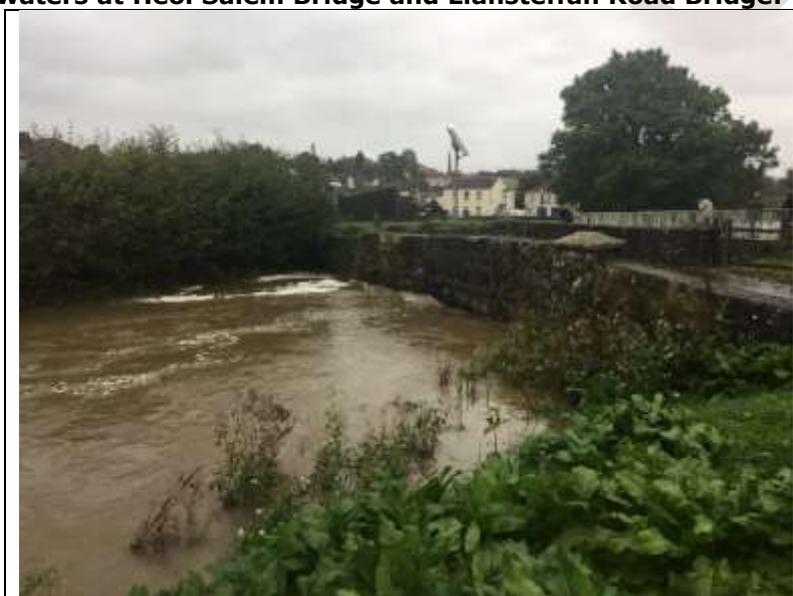
Plate 2: Flood waters at Heol Salem Bridge and Llansteffan Road Bridge.

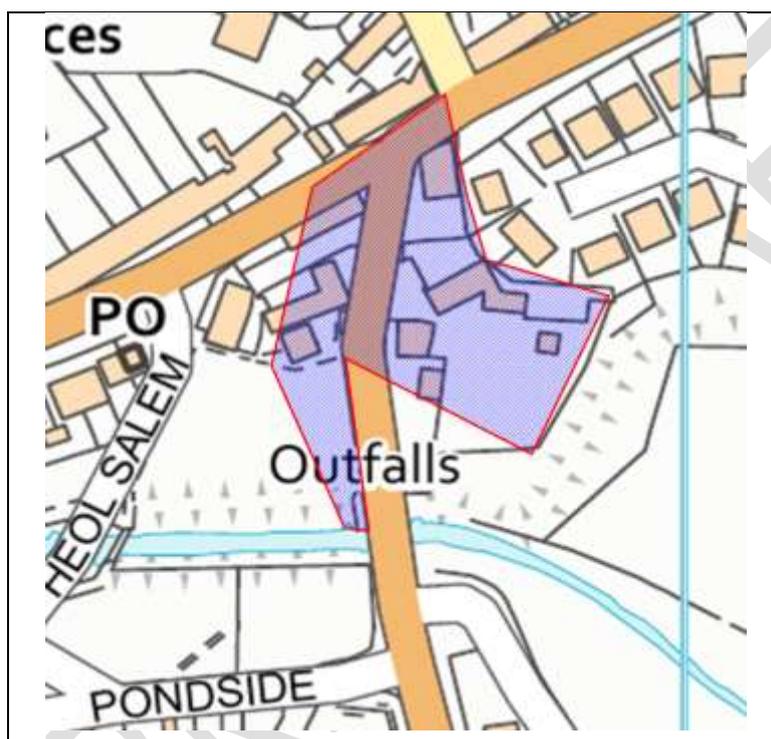
Figure 9 – Map of the Johnstown recreation ground and Llansteffan Road Investigation area

It has also been reported that flooding in this area was from manholes in the highway which lifted under the force of the water inside. This flood water inundated the highway before spreading to affect local residential and commercial property.

Investigations have also concluded that contractors working on behalf of CCC removed a section of the NRW flood defence embankment while undertaking improvements to the adjacent walkway along Llansteffan Road. The actions were undertaken of the contractors own volition without the knowledge of CCC. This breach in the flood defence allowed flood flows to escape the Tawelan Brook. The breach was repaired by the contractor in liaison with CCC and NRW.

Action 3: Repair flood bank – COMPLETE.

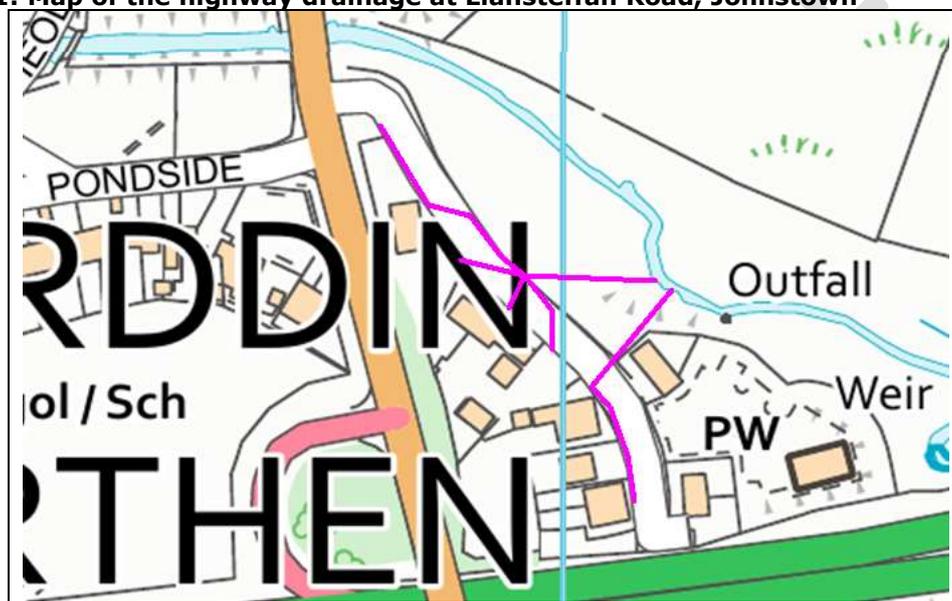
Investigations have revealed that there is a DCWW foul system and two highway surface water systems serving Heol Llansteffan. The highway surface water systems discharge into the Tawelan Brook approximately 40 metres to the east. There is a DCWW overflow on the upstream end of the sewer (see Figure 11 below).

Given the elevated water levels in the Tawelan Brook and the levels of the outfalls, free discharge would have been restricted. This would have resulted in water 'backing up' in the system as the continued rainfall could not drain away.

Figure 11: Map of the highway drainage at Llansteffan Road, Johnstown

Action 6: Clarify drainage asset owners and management responsibilities (Heol Llansteffan, Johnstown) COMPLETE

Action 7: Investigate the presence and functionality of the non-return valves in the highways drainage systems (Heol Llansteffan, Johnstown) COMPLETE

Action 8: Jet/clean the drainage system and action repairs accordingly (Heol Llansteffan, Johnstown)

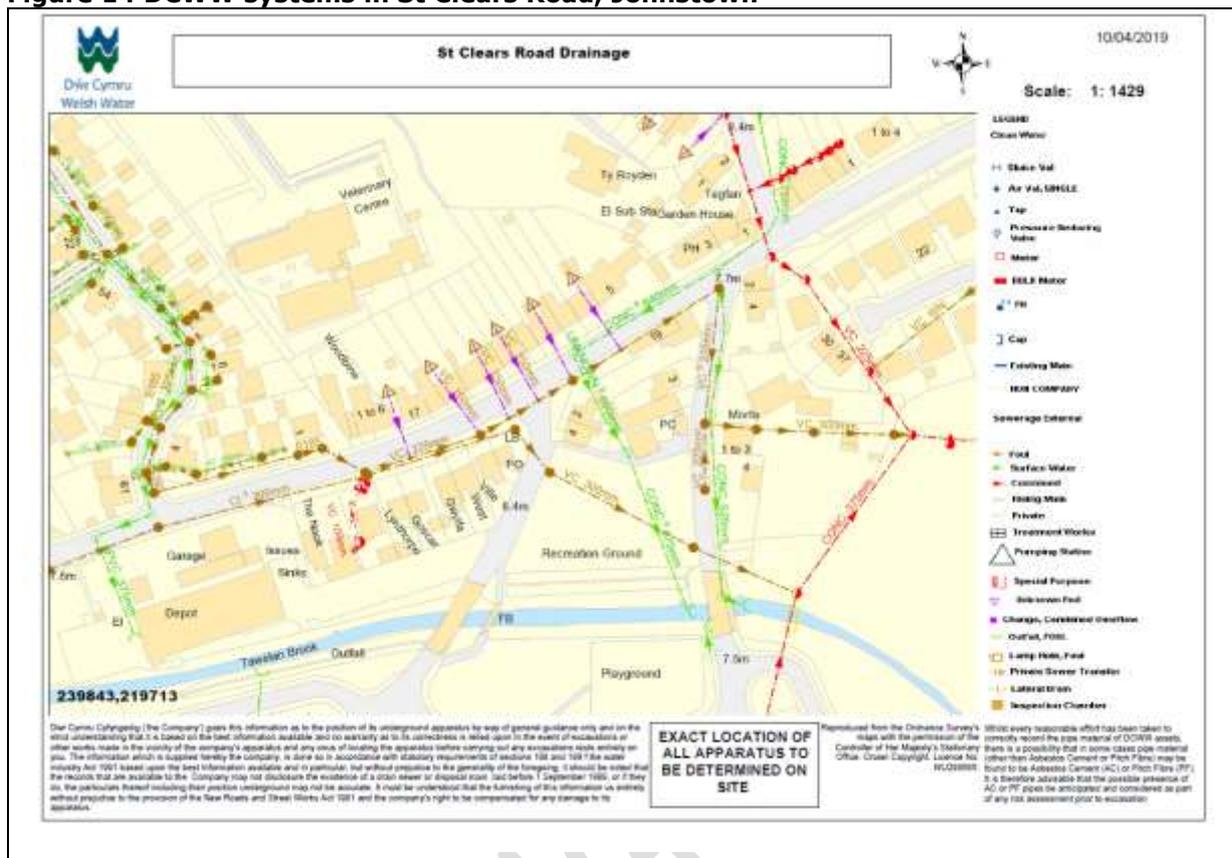
Investigations have concluded that there are two DCWW surface water systems in this area of St Clears Road (Figure 13). One drains Parc Starling and the second is an overflow that drains runs under the eastern end of St Clears Road. Unfortunately there are also gaps in knowledge pertaining to the highway drainage system.

Figure 14 DCWW systems in St Clears Road, Johnstown

Highways Authority	Ian Thomas	11	Highways Authority to undertake investigations to clarify the layout of the drainage in St Clears Road, Johnstown.	Undertake a CCTV survey of the highway network to identify its location, size and condition.	Medium	Oct 2019
DCWW & Highways Authority	Richard Davies DCWW Ian Thomas CCC	12	DCWW and the Highways Authority to evaluate the standard of service that is afforded by the drainage system in St Clears Road, Johnstown.	Utilise the CCTV information gathered on pipe sizes, along with catchment and rainfall information to calculate the standard of service.	Medium	Oct 2019
DCWW & Highways Authority	Richard Davies DCWW Ian Thomas CCC	13	DCWW and the Highways Authority to evaluate management options for exceedance in St Clears Road, Johnstown.	Formulate a flood risk management plan to manage highway flooding.	Medium	Oct 2019
NRW	Aneurin Cox	14	NRW to evaluate the need to raise the flood bank at Maes Y Dderwen, Johnstown, Carmarthen.	Undertake an assessment of the flood banks and deliver works to ensure the standard of service can be achieved.	Medium	Nov 2019

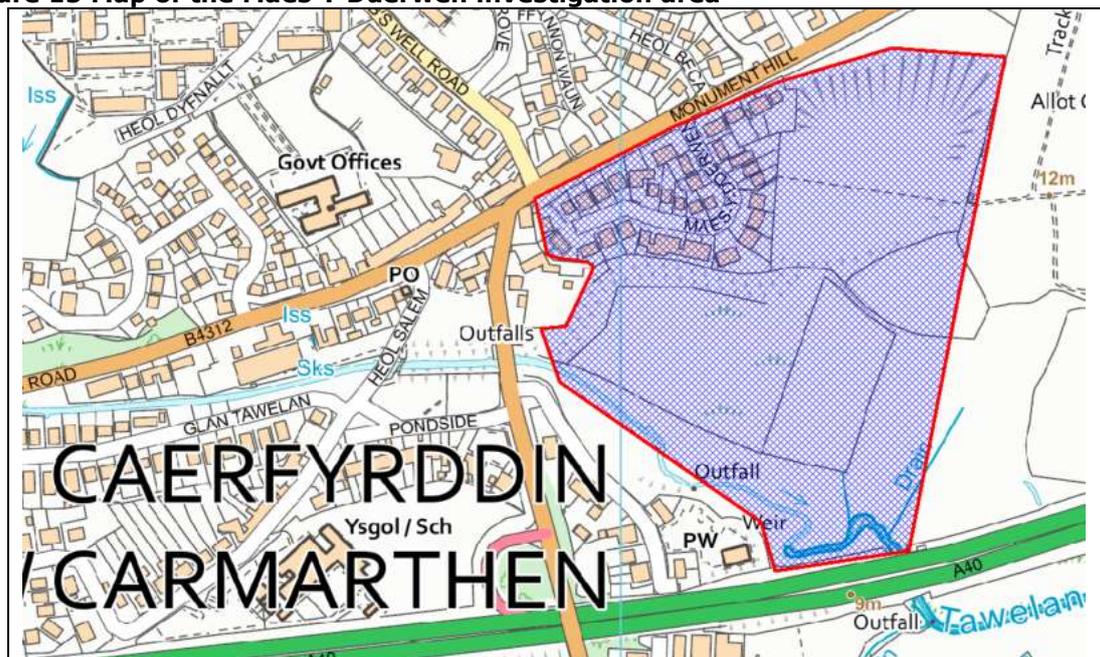
Figure 15 Map of the Maes Y Dderwen investigation area

Action 14 NRW to evaluate the need to raise the flood bank at Maes Y Dderwen, Johnstown, Carmarthen;

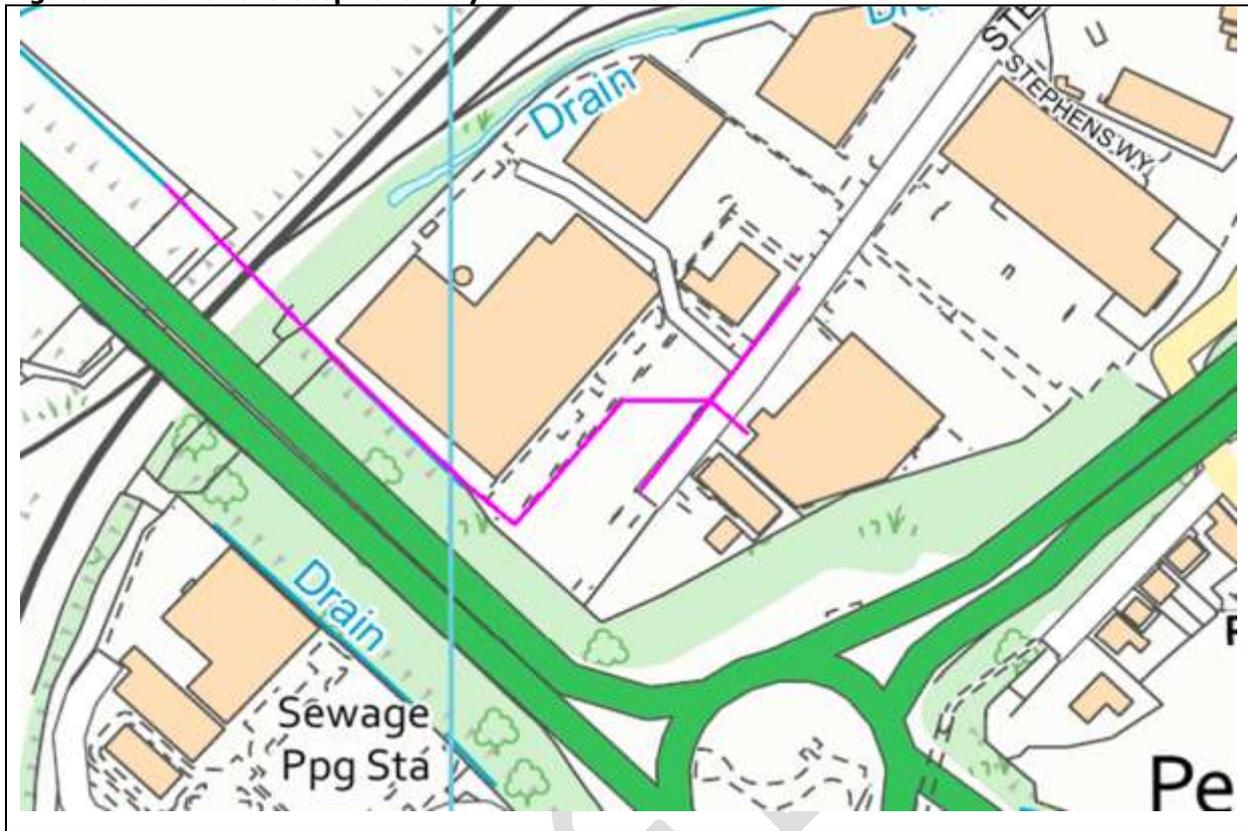
Figure 9: Plan of the Stephens Way Retail Park storm water sewer.

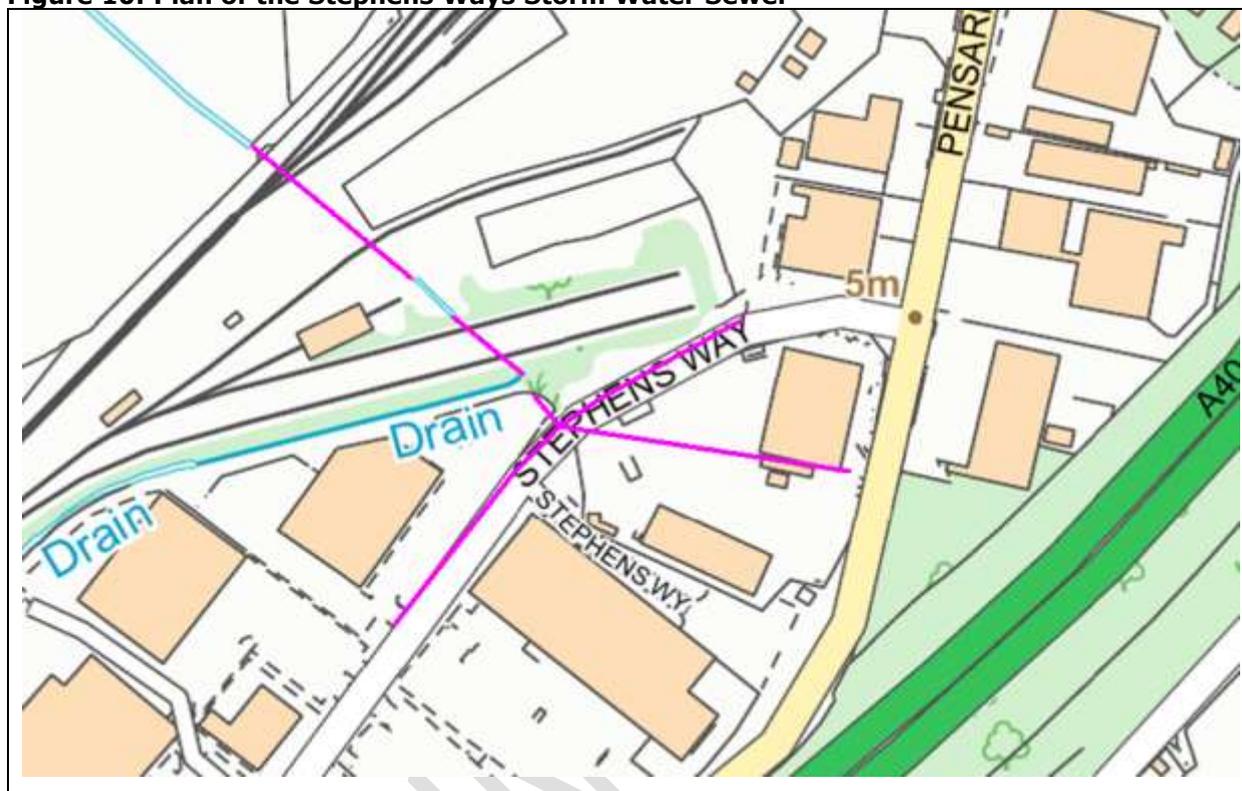
Figure 10: Plan of the Stephens Ways Storm Water Sewer

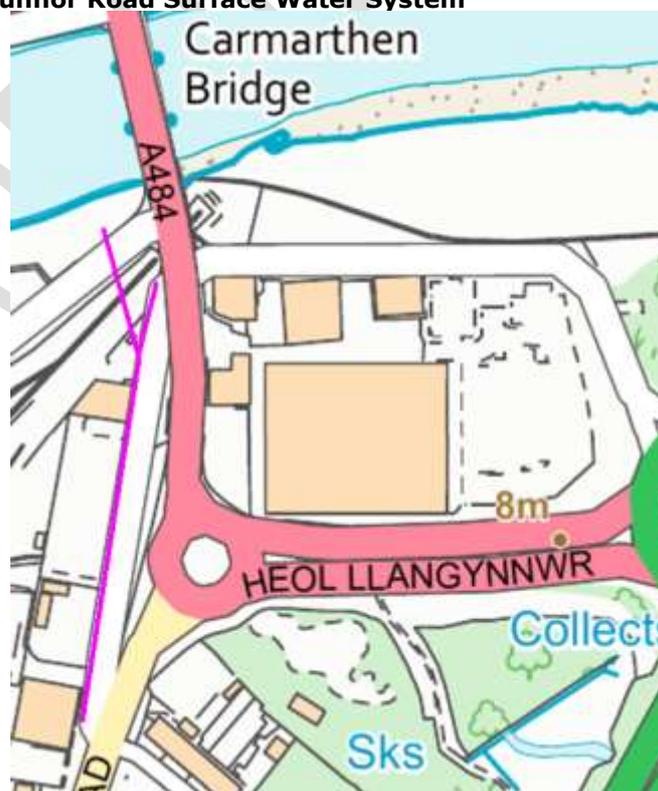
Figure 11 Old Llangunnor Road Surface Water System

In light of the information above and the results of a CCTV drainage survey, this report has concluded that the drainage system has sufficient capacity to manage all of the above storm events.

Action 18: Undertake a CCTV survey of Old Llangunnor Road and the Currys PC World car park to ascertain its network, structural and service conditional and its future maintenance liability.

Action 19: Undertake a CCTV survey of Old Llangunnor Road (east of the A40) to ascertain its network, structural and service conditional and its future maintenance liability.

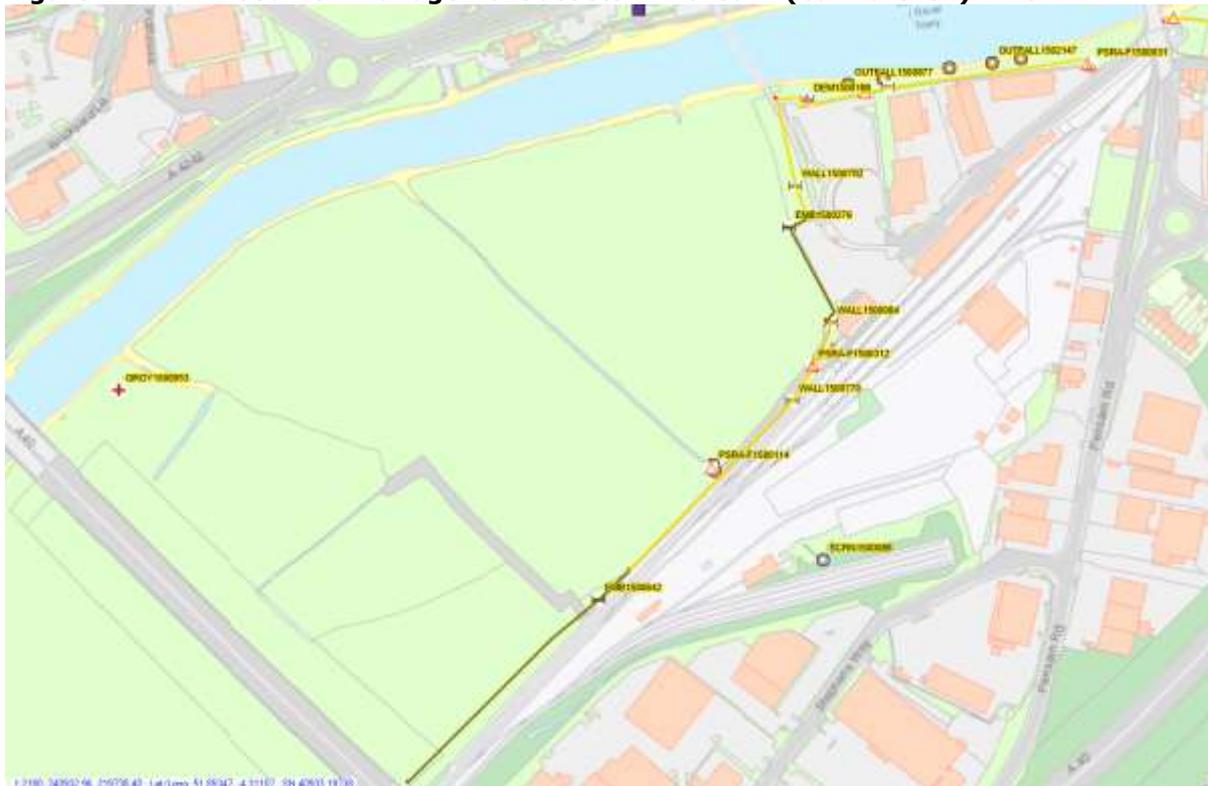
Figure 12 NRW flood risk management assets in Pensarn (Carmarthen) WEST

In 1984 Old Llangunnor Road wall was raised a further 250mm. New Defences were installed at Bridge Wharf, Old Station Road and along the Railway line. The railway bridge across the Towy was also removed. However in October 1987 Pensarn was flooded again when the defences were overtopped. This event was assessed as a greater than 1 in 100 probability event.

In 1991 the first recommendations from the modelling exercise were undertaken (Carmarthen FAS Phase 1 – “Waterway Improvements”). These included re-aligning the River Towy for smoother flow entry under Bascule Railway Bridge.

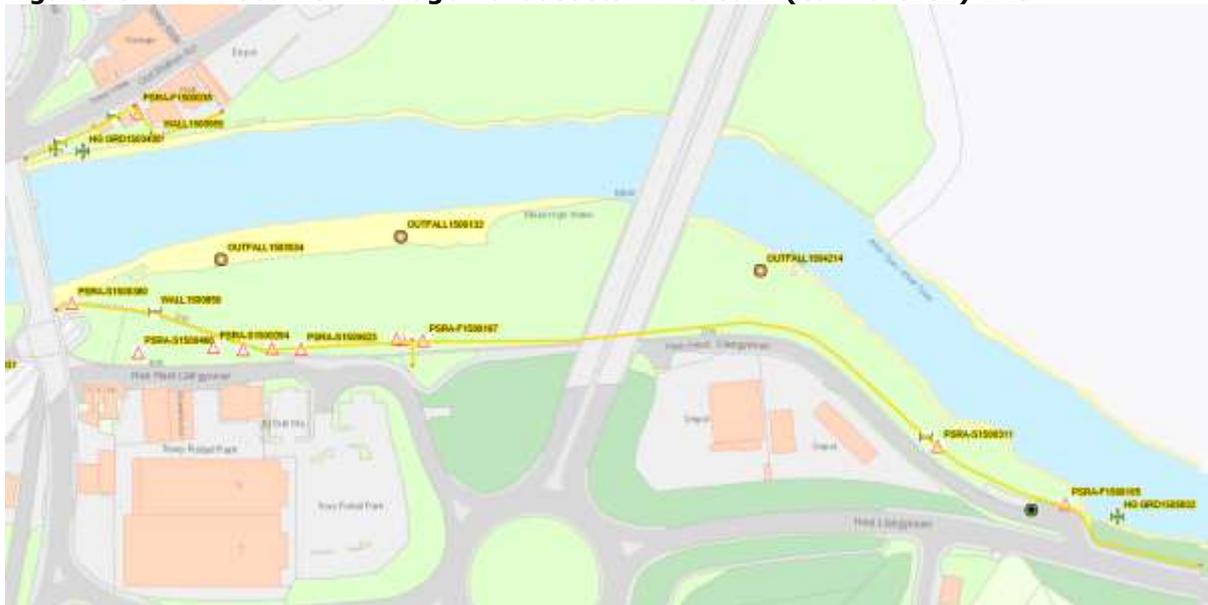
Figure 13 NRW flood risk management assets in Pensarn (Carmarthen) EAST

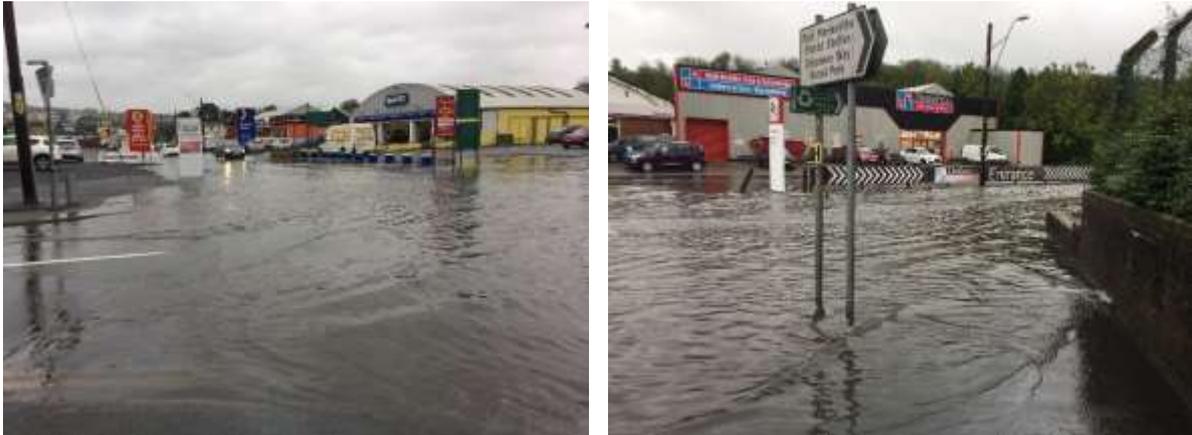
Plate 4 Photographs of the Flooding along Pensarn Road on Saturday 13th October 2018 at 1515.

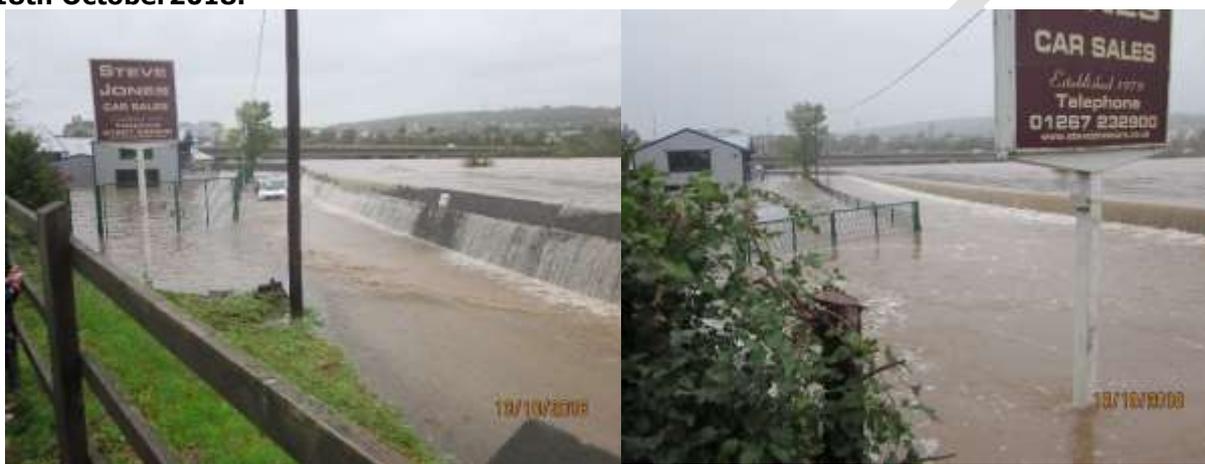
Plate 5 Photographs of the flood defences at Old Llangunnor Road on the afternoon of 18th October 2018.

NRW have employed a Panel Engineer to undertake an assessment of the wall and make recommendations to resolve the issues. NRW have no plans to increase the height of the wall at this time.

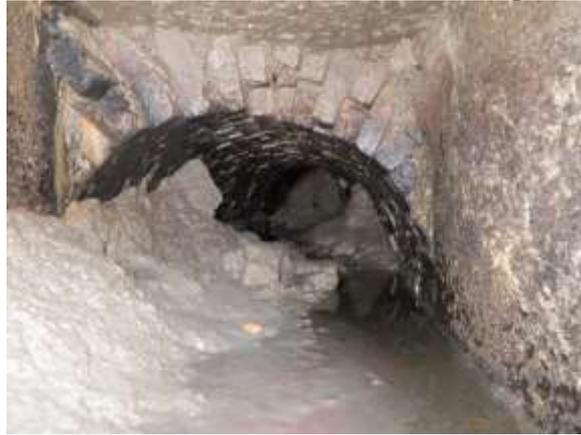
Plate 6: A partially blocked surface water sewer off Old Llangunnor Road, Pensarn.

Action 25: Network Rail to investigate and repair the section of blocked culvert at Old Llangunnor Road, West.

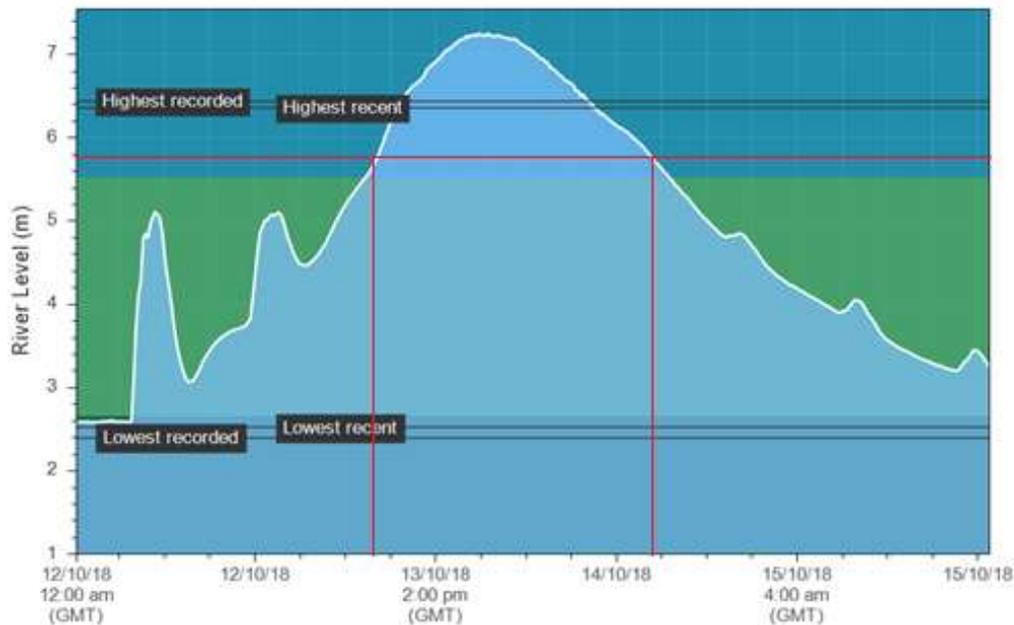
This report has concluded that the pump cannot be accurately evaluated without a robust understanding of all the storm flows it is likely to have to manage. As such the following actions have been recommend to ensure a robust assessment can be undertaken in the near future.

Figure 15 Graph highlighting the period of time that the River Tawe would have limited the functionality of the pump

Action 26: Evaluate the capacity of the storm water sewers in Pensarn Road - COMPLETE

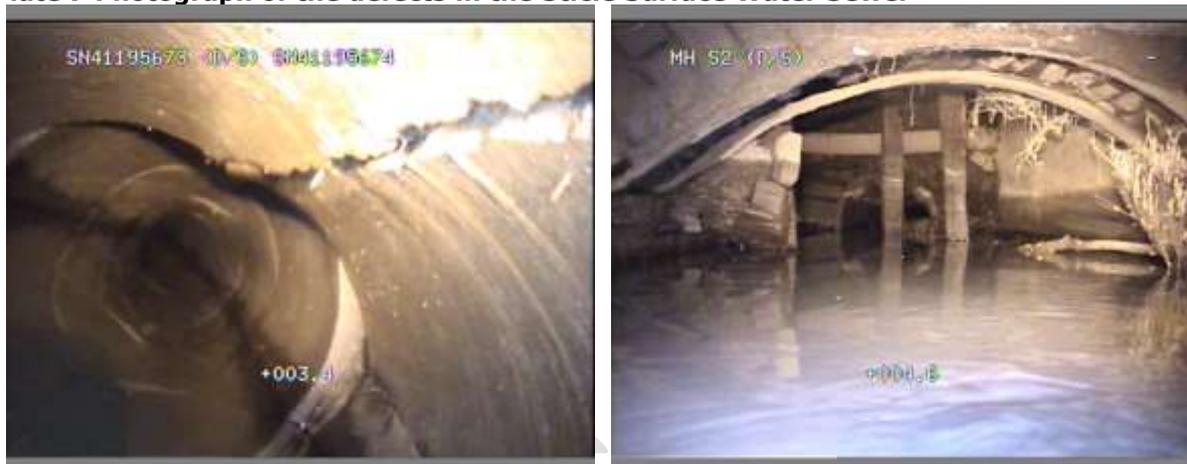
An evaluation of the Sticle surface water sewer concluded that it was a private storm water sewer and that there was sufficient capacity to manage storm flows. However, a CCTV surveys has revealed structural defects that require repair.

Plate 7 Photograph of the defects in the Sticle Surface Water Sewer

Action 31: Identify the owners of the Sticle Storm water Sewer - COMPLETE

Action 32: Ensure the necessary repairs are undertaken to the Sticle Storm Water sewer

Action 32: Ensure the necessary repairs are undertaken.

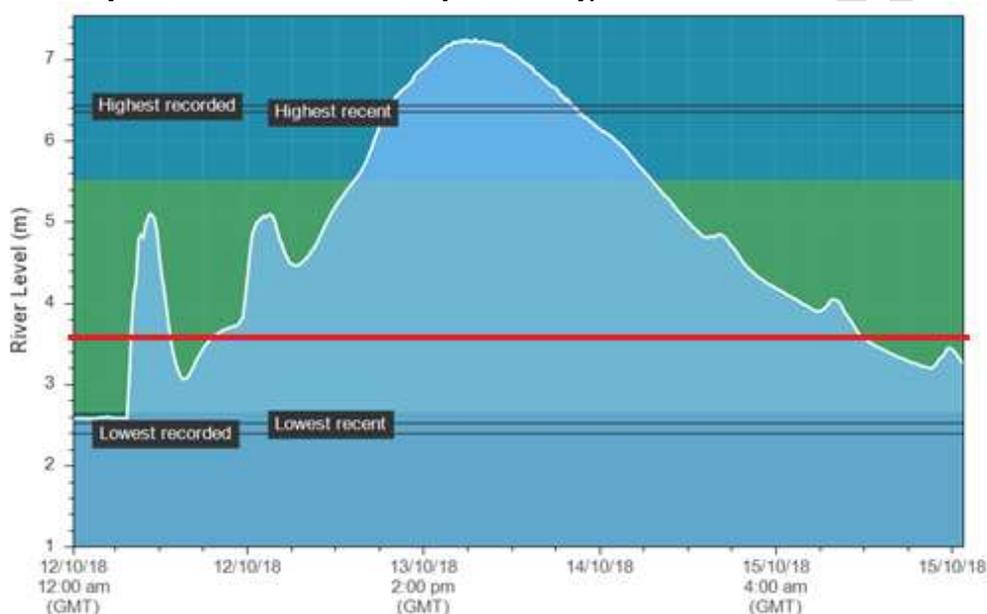
CCTV investigation has revealed that the area is serviced by two private storm water sewers. Both systems have been identified as having service and structural defects that need addressing. As detailed above, there is sufficient capacity in the system to manage the storm flows however, given the extent of the defects, this report concludes that they were a contributing factor, adversely affecting conveyance and capacity.

Figure 16: Graph highlighting the period of time that the River Towy would have limited the functionality of storm outfalls at Stephens Way, Pensarn.

Action 33: Inform the storm water sewer benefactors in Stephen Way of their obligations with regards to the drainage system and advise them to make the repairs identified.

CCC FD&CP	Ben Kathrens	33	Inform the drainage system benefactors of their obligations with regards to the drainage system and advise them to make the repairs identified at Stephens Way.	Write to the benefactors requesting a financial contribution and if unsuccessful evaluate issuing a notice under the Land Drainage Act 1991.	Medium	Oct 2019

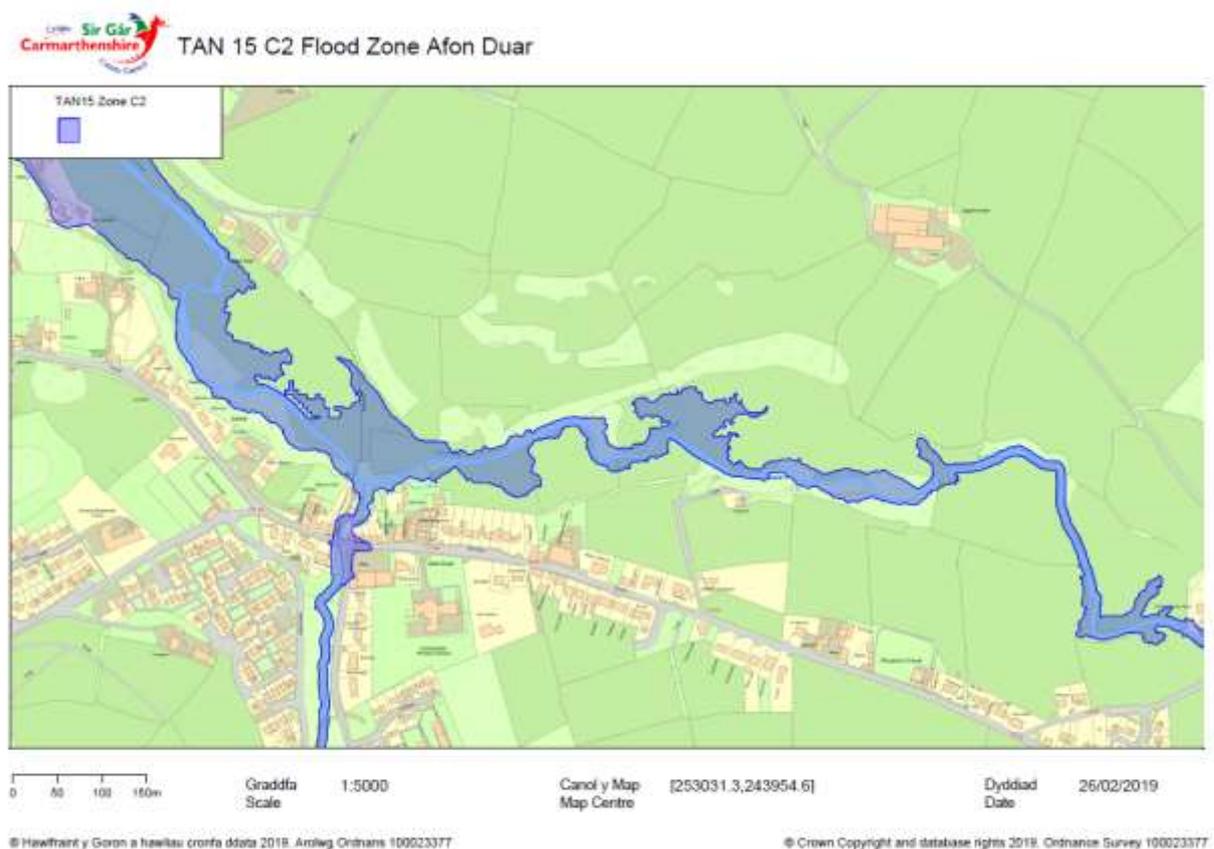
Figure 19 Welsh Government Development Advice Flood Map for the Afon Duar, Llanybydder.

The catchment of this watercourse is 14.64km². Analysis of the flood flows has been undertaken and is shown in Table 9. The area at risk of fluvial flooding is highlighted on the Welsh Government Development Advice Map (DAM) below in Figure 19.

1 in 100 annual probability Peak flow (metres cubed / second)	Annual probability Peak flow (metres cubed / second)	1 in 30 annual probability Peak flow (metres cubed / second)
21.81	8.62	17.31

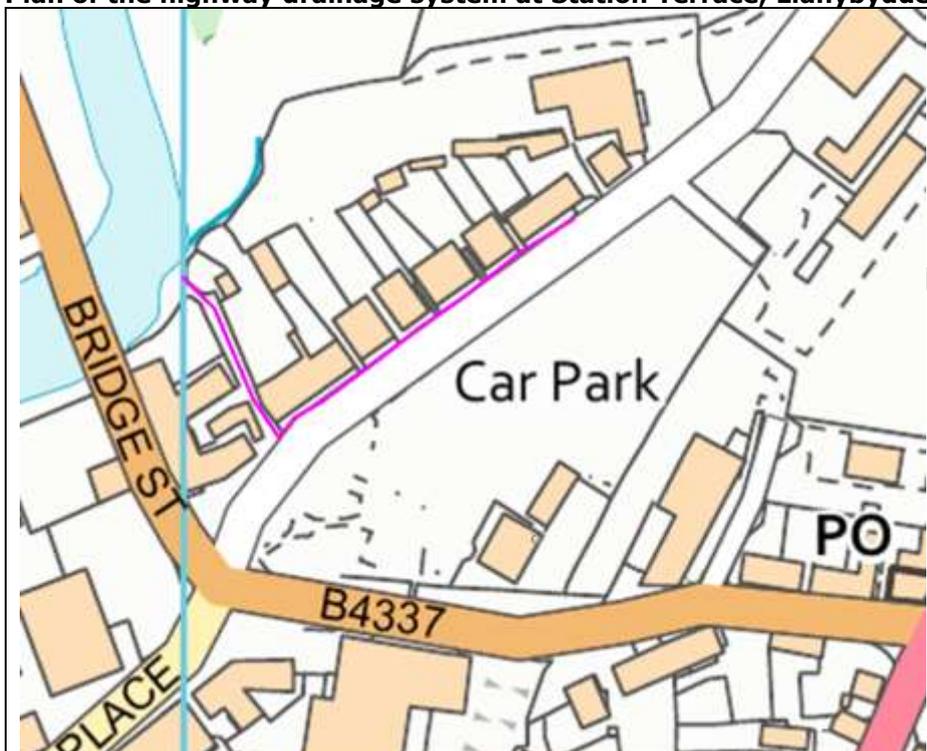
Figure 28 Plan of the highway drainage system at Station Terrace, Llanbydder

At Highmead Terrace, site visits have ascertained that the highway discharges to the adjacent flood plain. At Station Terrace, the Highways Authority have stated that there is an independent highway drainage system. Gullies drain the carriageway and the footway. The drainage system runs southwest down Station Terrace before turning north, alongside No.1 Station Terrace and to the River Teifi. The standard of service and condition of this system is not known.

Action 34 Undertake a CCTV survey of the highways drainage at Station Terrace, to ascertain the condition and standard of service.

Action 34: Undertake a CCTV survey of the highways drainage at Station Terrace, to ascertain the condition and standard of service.

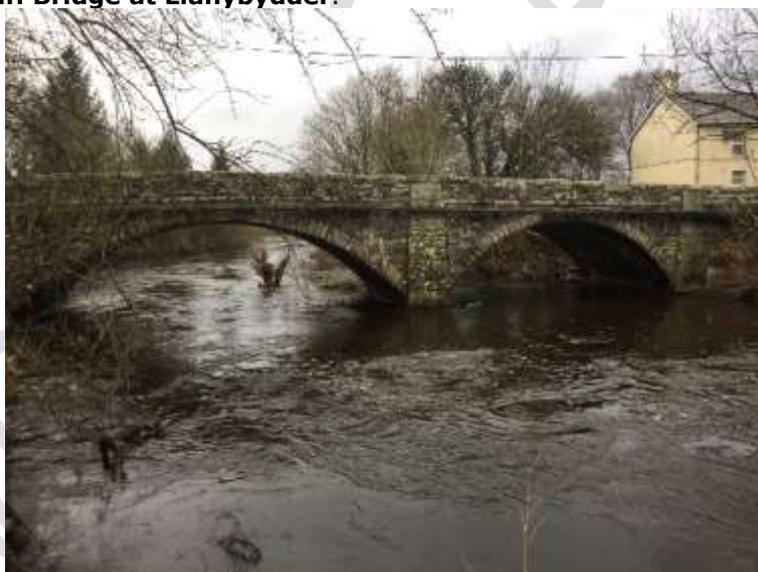
Plate 8 River Teifi Bridge at Llanybydder.

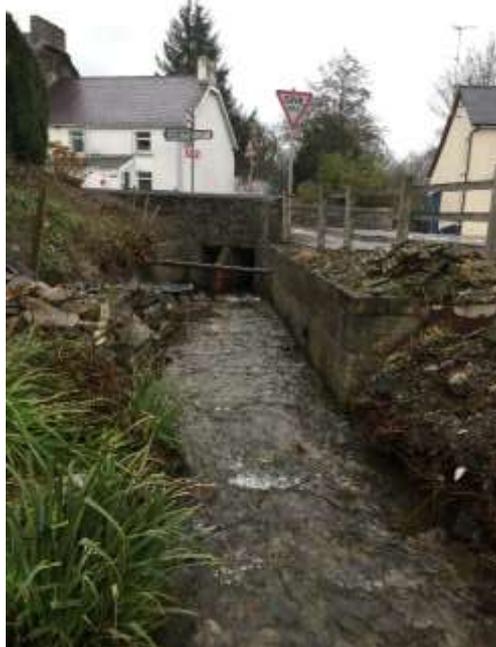
The culvert beneath the B4337 at Heol Dderi (Ref B4337_6) is a twin, rectangular culvert with a varying diameter (Plate 9).

Plate 9 Photograph of the Nant Einon upstream of the B4337 highway culvert.

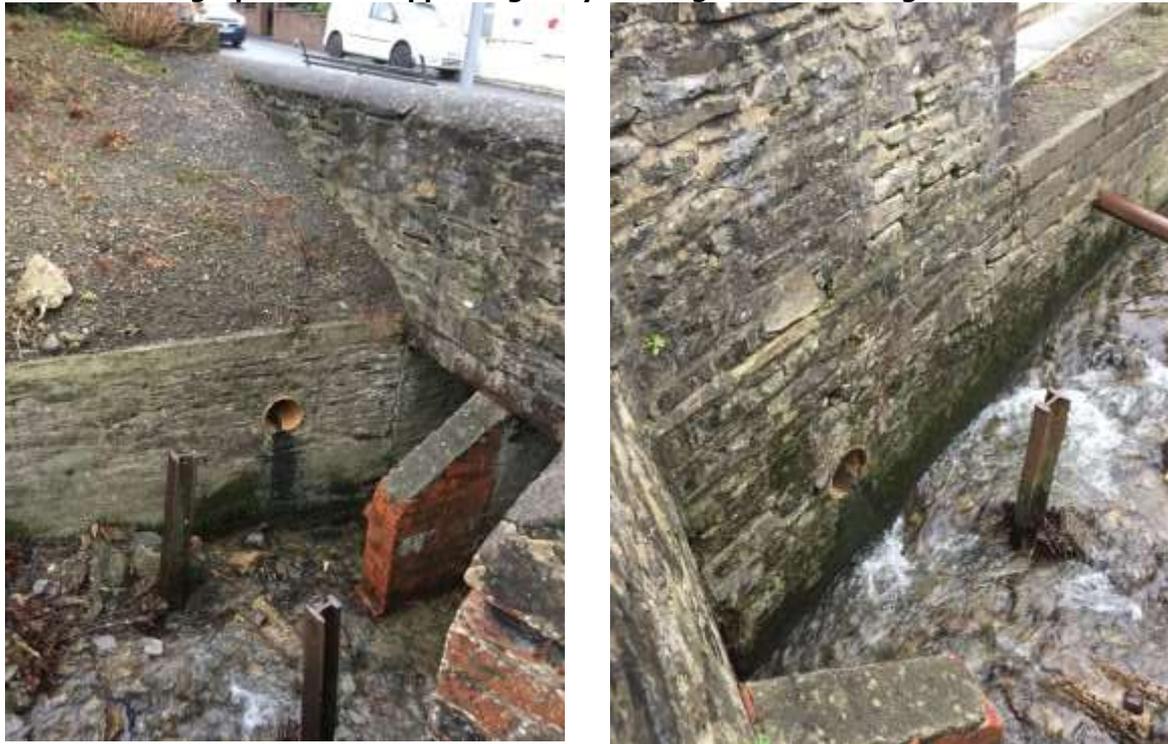
Plate 10 Photographs of un-flapped highway drainage outfalls along the Nant Einon.

Action 44: Add flaps to the outfalls of the highway drainage.

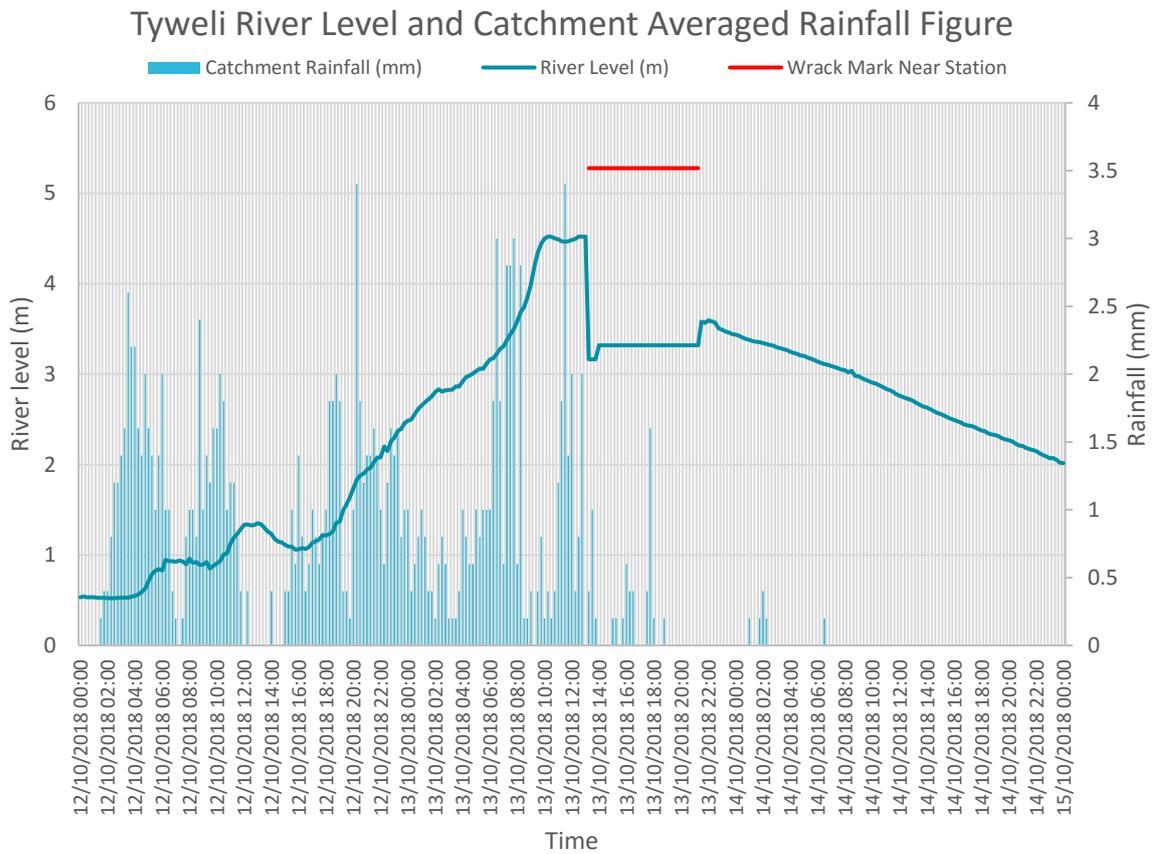
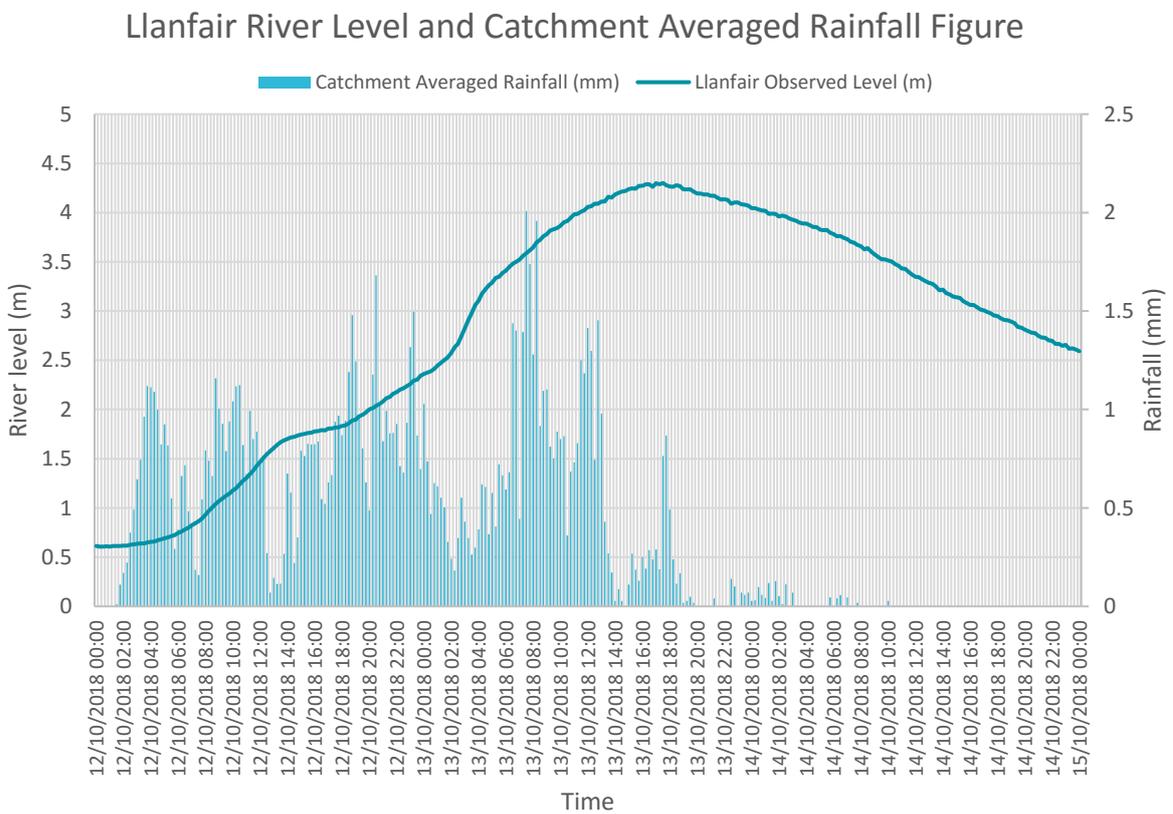
Figure 26 River Teifi and Tyweli Levels & Catchment Rainfall Figures (NRW)

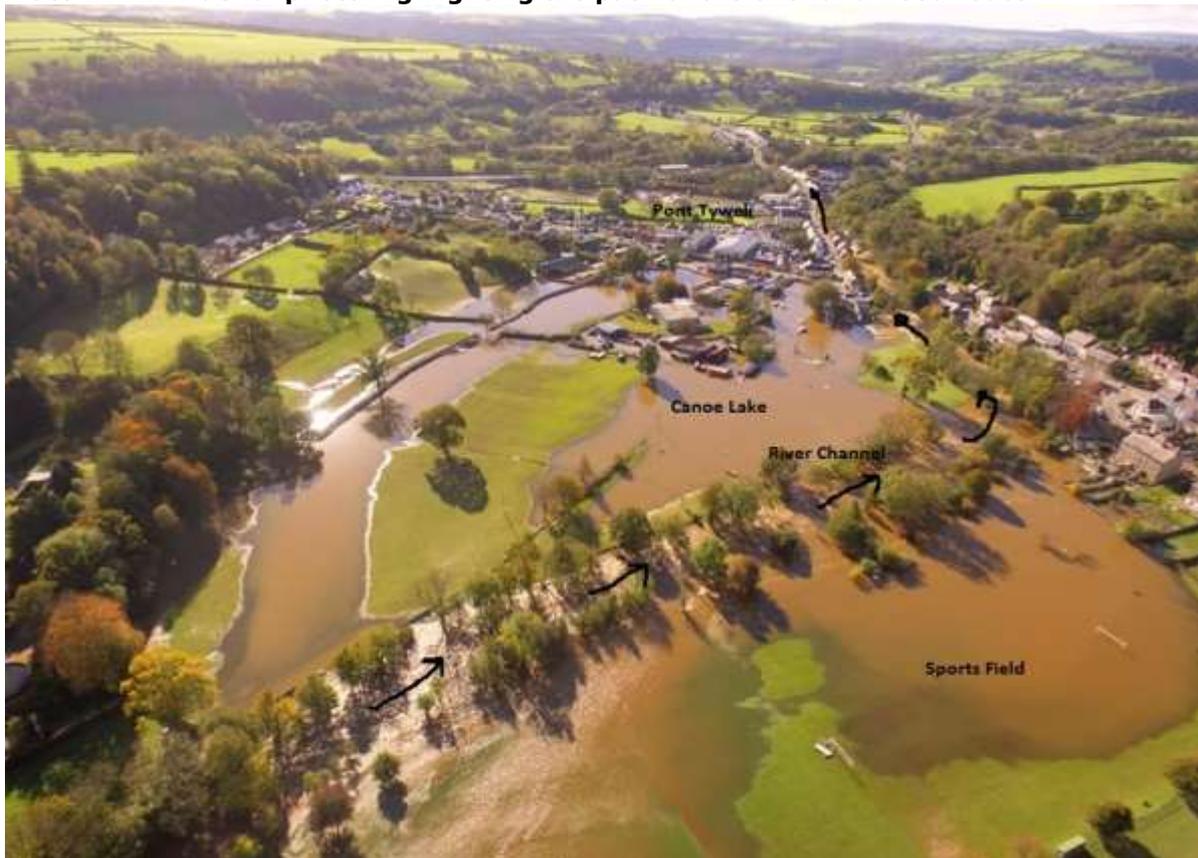
Plate 11 NRW aerial photo highlighting the path of the overland flood route.
