Investigation Report into Flooding- Storm Callum 12th - 14th October 2018

Title of document Storm Callum S19 Flood Investigation Report

Document date March 2019

Authors Carmarthenshire County Council

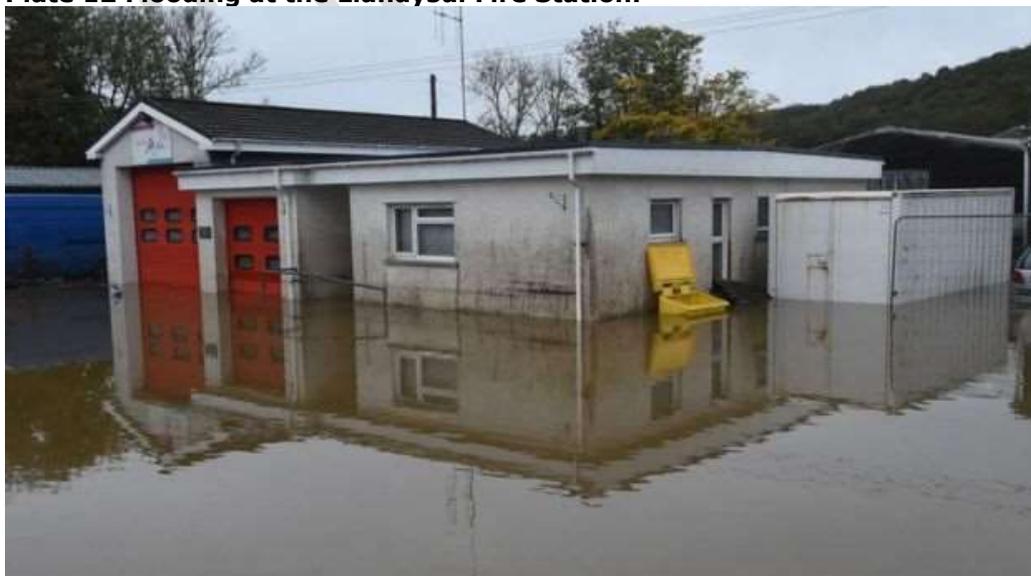
The volume of water was so great that the DCWW pumping station was submerged to a depth of over 2 metres and flood flows reached as far south as the garage and Nisa/Co-op store. This volume of water directed flood flows to the rear of the Lewis Street properties via the lane at the side of the Nisa store.

Plate 12 Flooding at the Llandysul Fire Station.

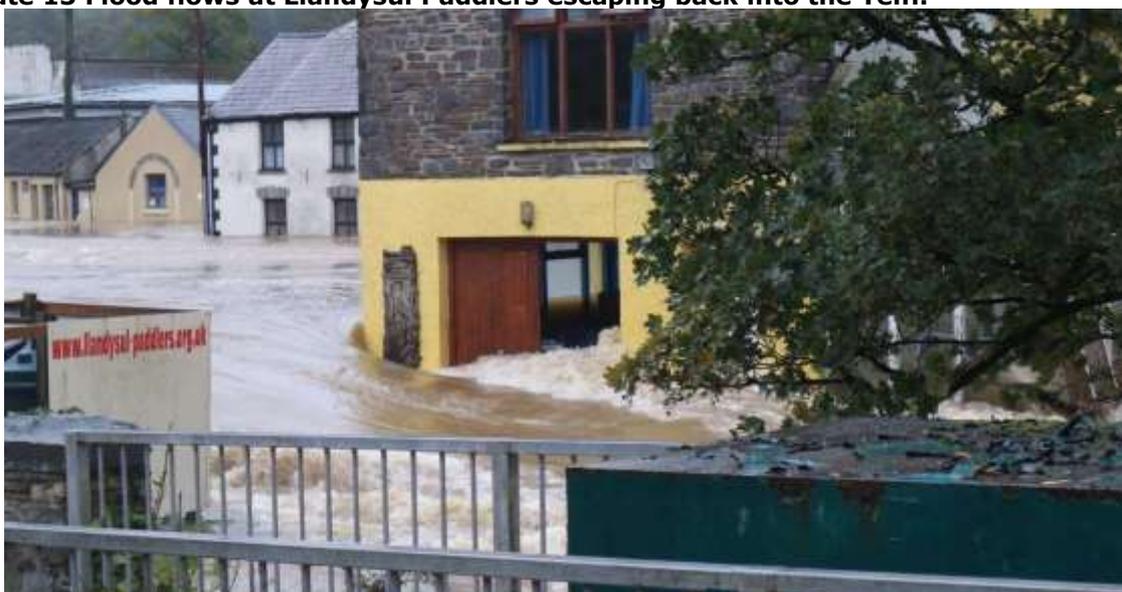
The main overland flood flows appear to have followed the contours of the land south of the paddling pond, through the car park and towards the new Llandysul paddlers club house. Initially water escaped back into the Teifi, immediately downstream of the road bridge, but as water volumes increased, flood flows were directed along Lewis Street. Plate 13 shows the volume of water trying to re-enter the River Teifi below the Llandysul road bridge.

Plate 13 Flood flows at Llandysul Paddlers escaping back into the Teifi.

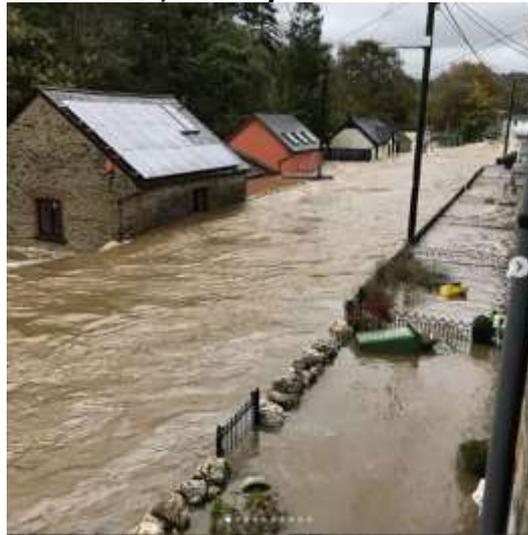
It is believed that the highway drainage initially captured the water along Lewis Street but this was quickly overwhelmed. The investigation has highlighted that the overland flood flows could not drain back into the Teifi from Lewis Street as there were insufficient breaks in boundary walls to allow water to re-enter the main channel. As such the flooding was channelled south west towards Pont Tyweli. Plate 14 below shows the level of flood flows along Lewis Street.

Plate 14 Flood water at Lewis Street, Pont Tyweli.

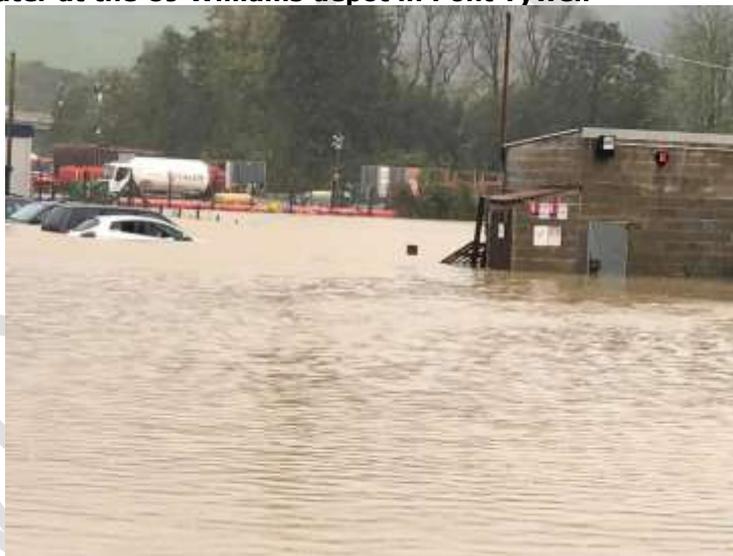
At the southern end of Lewis Street, it was reported that flood water flowed into the OJ Williams yard. Investigation have shown that the yard is lower than the level of the highway and subsequently water naturally flowed there and combined with flood flows from the River Tyweli as shown in Plate 15.

Plate 15 Flood water at the OJ Williams depot in Pont Tyweli

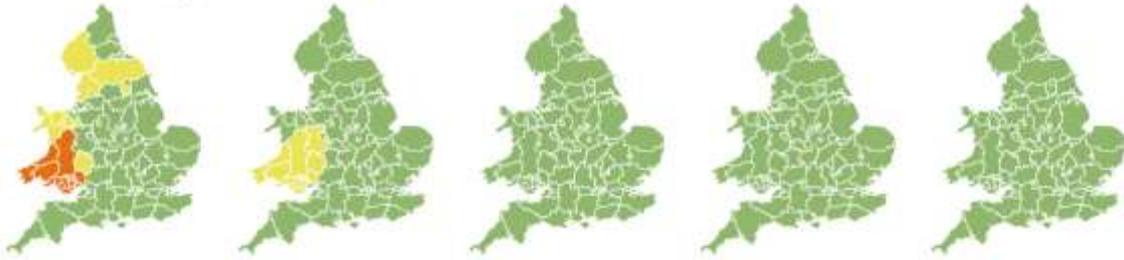
Saturday 13 Oct 2018 10:30-23:59 Trend since Last FGS	Sunday 14 Oct 2018	Monday 15 Oct 2018	Tuesday 16 Oct 2018	Wednesday 17 Oct 2018
Steady →	Steady →	Steady →	Steady →	Steady →

Significant river and surface water flooding impacts are expected in south Wales today (MEDIUM flood risk), and are possible for other parts of Wales. Minor flood impacts are probable today for parts of the north-west of England.

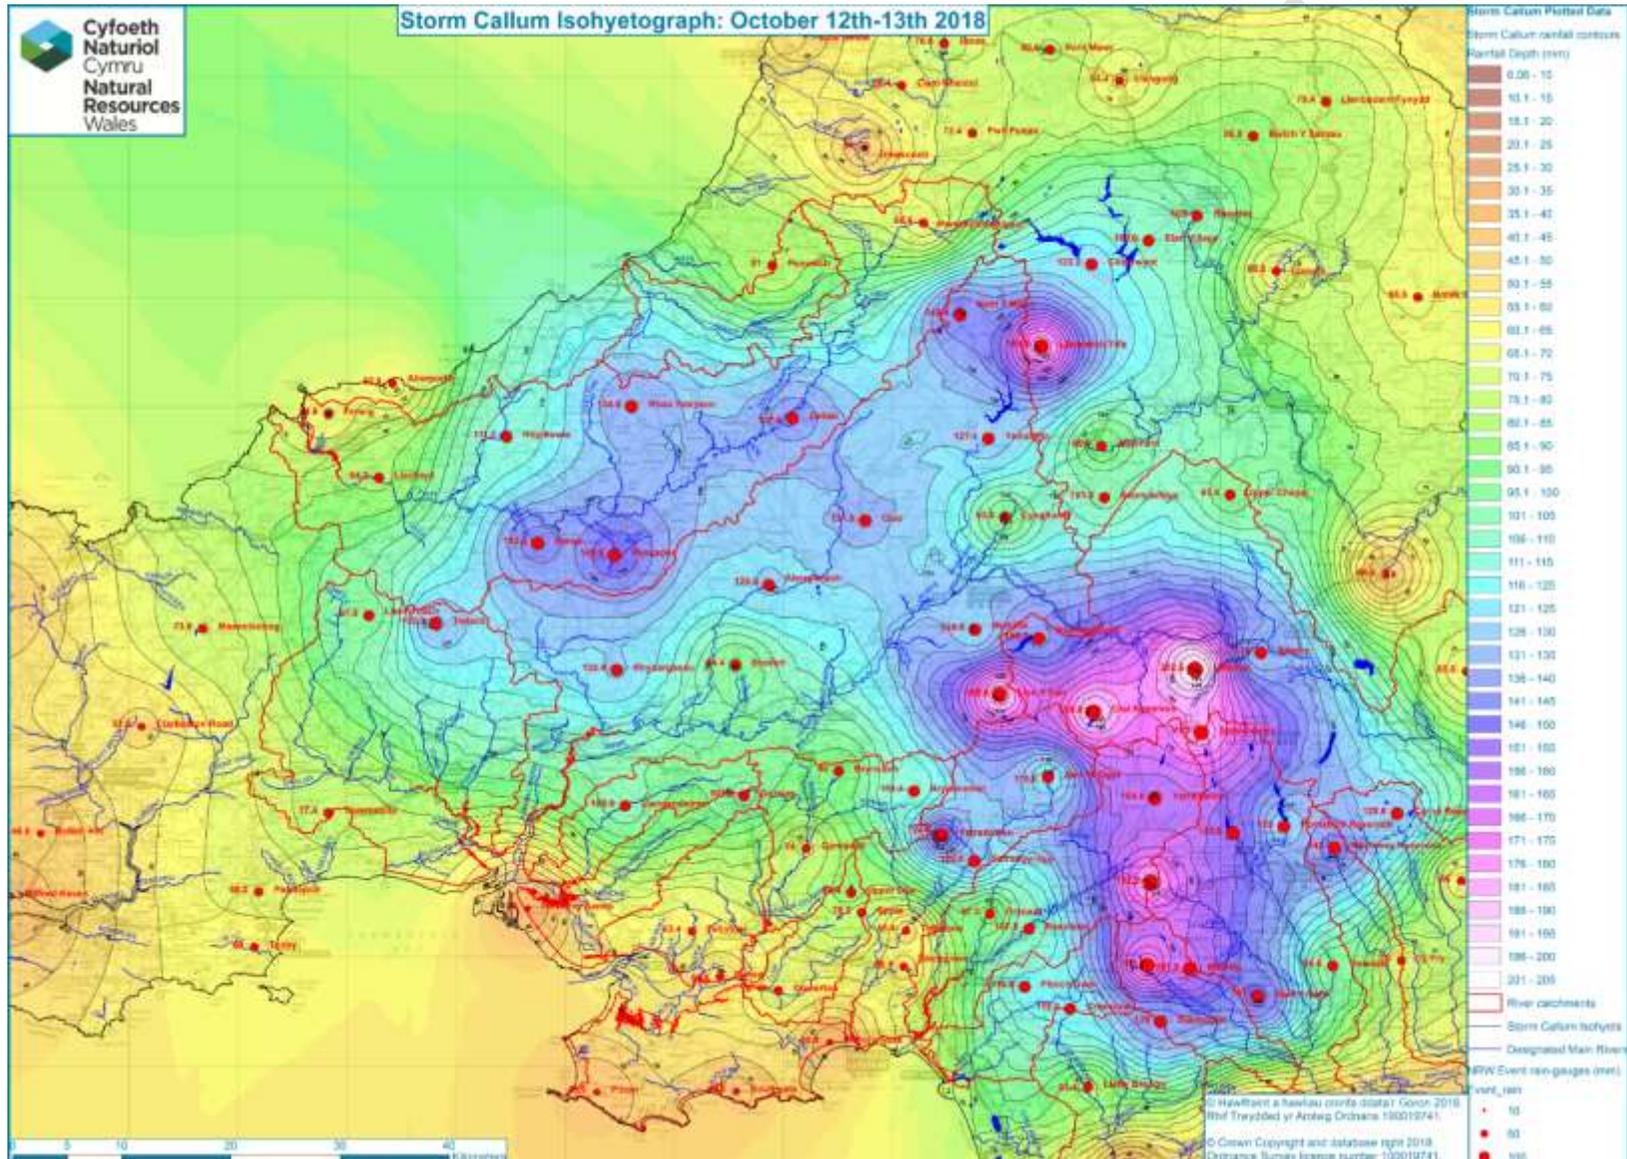
Appendix B - NRW isohyet map of south Wales over the 12th and the 13th October.

Natural Resources Wales have calculated that the annual probability for rainfall event associated with Storm Callum, in the upper catchment of the river Towy was between 1 in 100 and 1 in 330. NRW have also produced an isohyet map of south Wales that highlights the areas of highest rainfall over the 12th and the 13th October. This can be viewed in **Appendix B**.

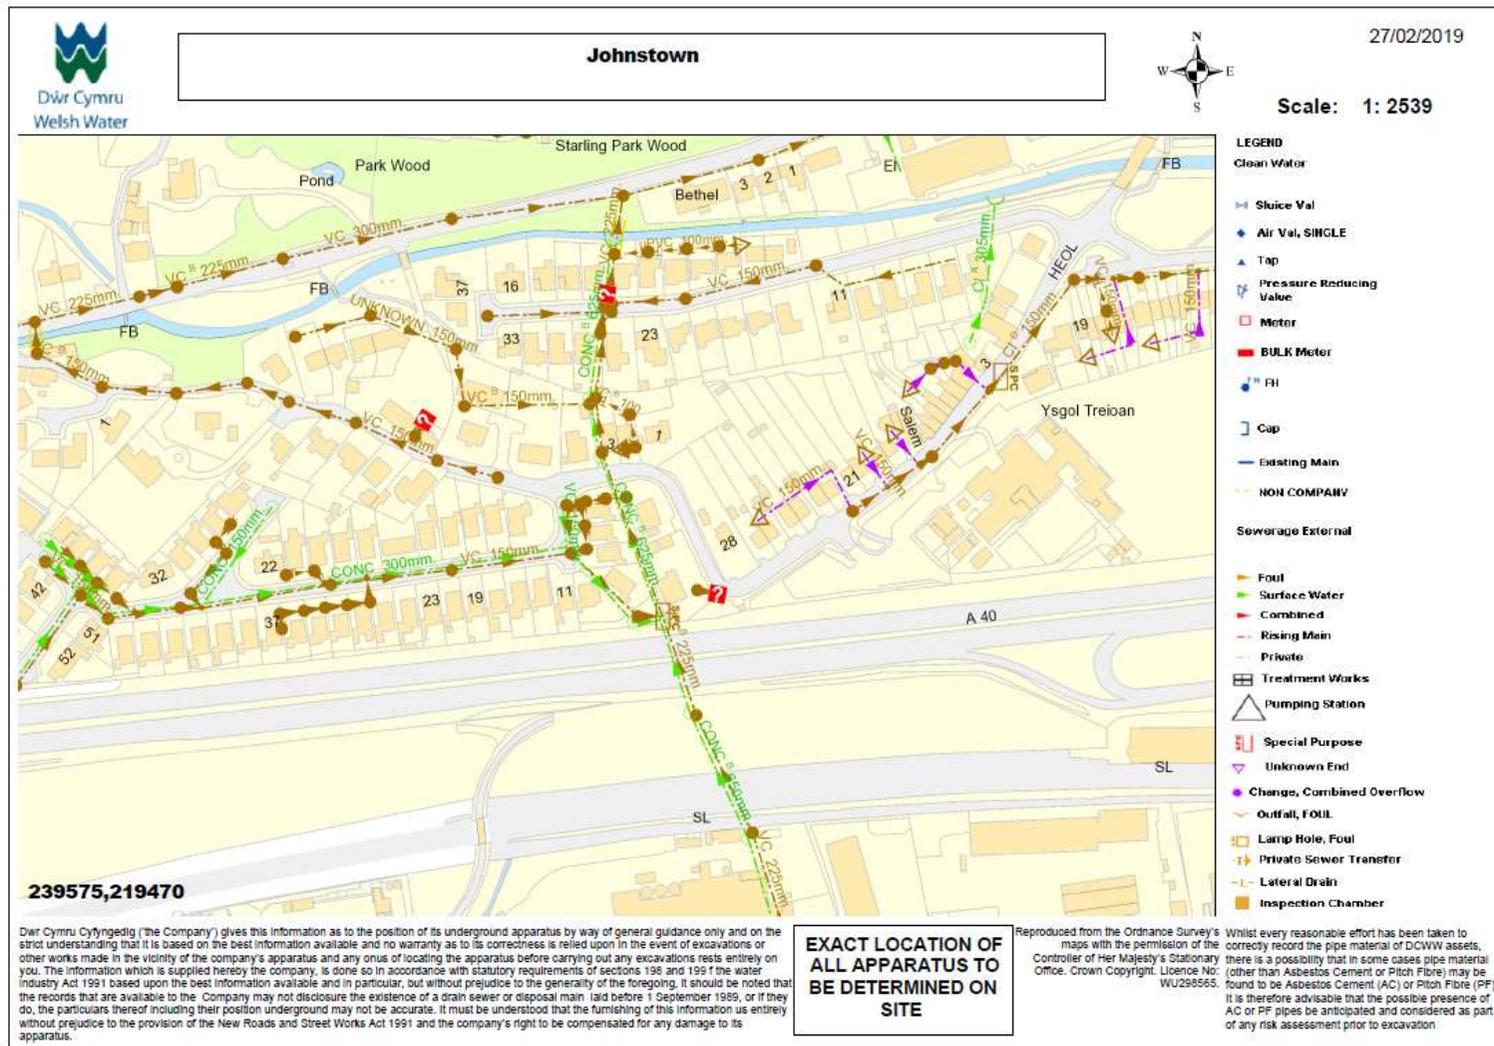
Appendix C - DCWW database of the drainage network

DCWW have the drainage network mapped on their database (see **Appendix C**). However, no information exists on the maintenance regime, the standard of service or condition of these assets.
